# Johnson's Quality Tree Care & Logging

## LAKE COUNTY RESOURCE CONSERVATION DISTRICT

# Hazardous Tree Risk Assessment

## *Summary Report | Cobb Area County Roadways*

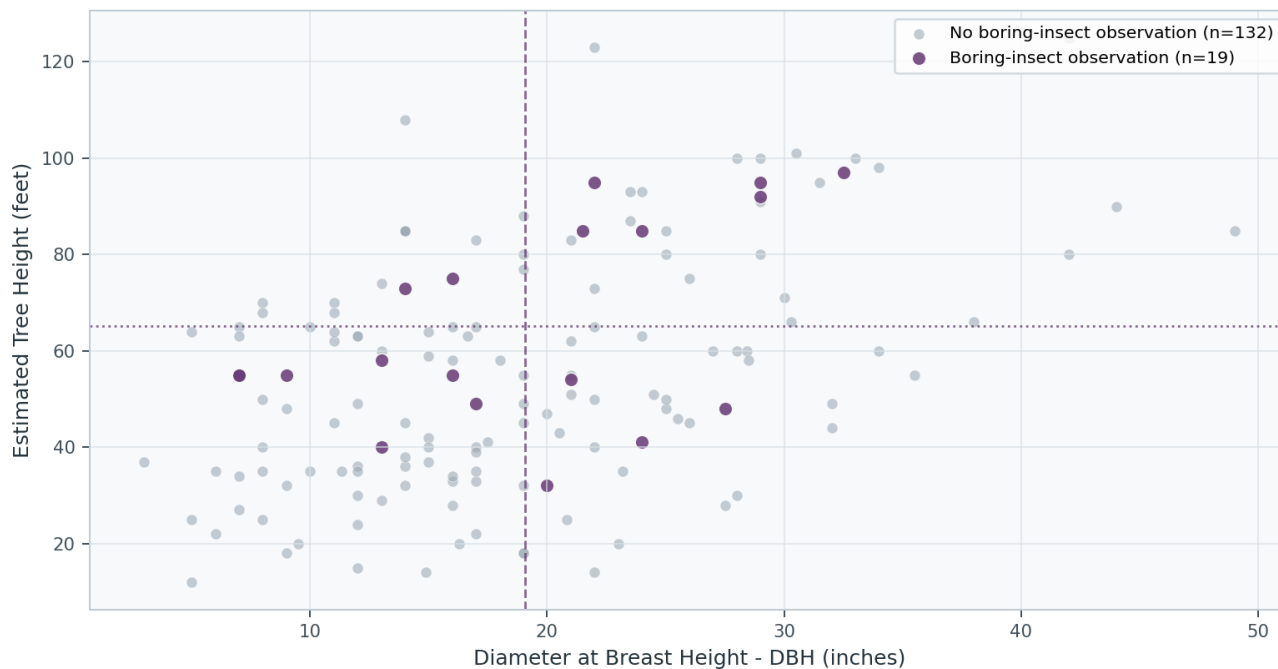
**Boring-Insect Observations by Tree DBH and Height**

The chart below compares DBH and estimated height for every inventoried tree with complete measurement data. Purple points represent the 19 trees with a recorded boring-insect observation; gray points represent the remaining 132 trees with no boring-insect observation recorded. These are visual field observations and should not be interpreted as laboratory-confirmed causes of mortality.

**Observed trend:** Trees with recorded boring-insect observations were similar in average diameter but approximately 10.5 feet taller than trees without a boring-insect observation. The wide overlap between the groups indicates that boring-insect activity was observed across a broad range of DBH and height classes rather than being limited to one tree-size category.

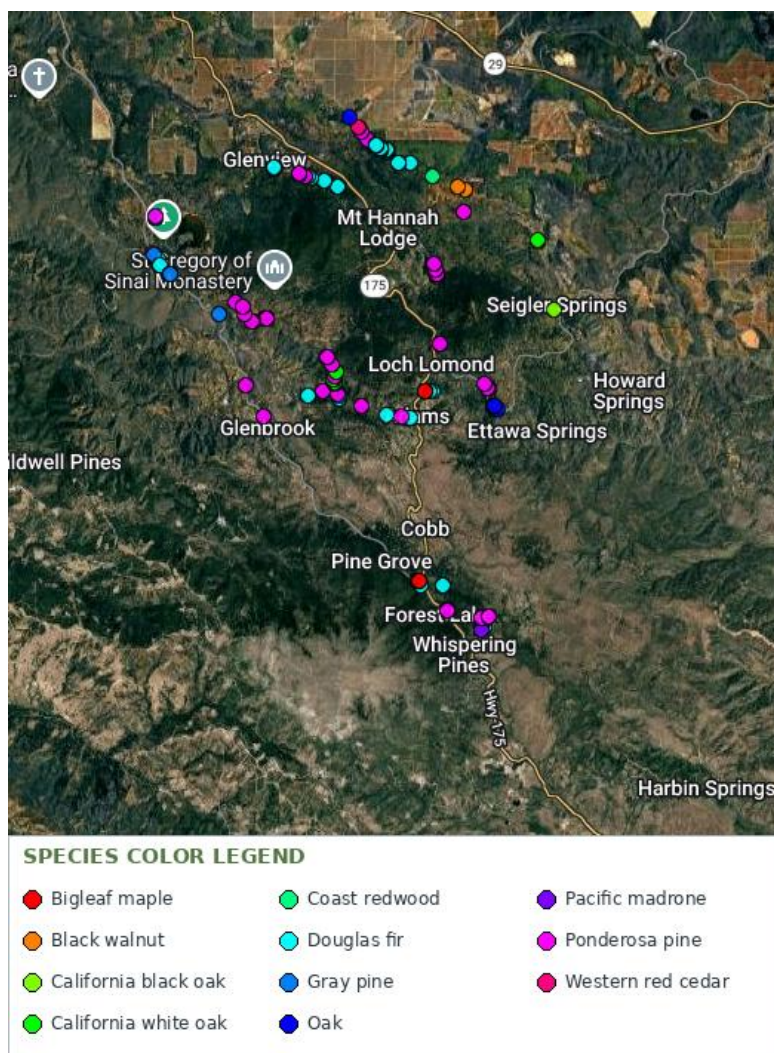
## Trees Recommended for Removal

This map shows the locations of all 141 trees recommended for removal within the assessed County right-of-way. Each mapped location corresponds to a removal recommendation in the comprehensive TreePlotter inventory. Trees recommended for removal were marked in the field with purple tree-marking paint consisting of one horizontal line on the trunk and a dot at the base of the tree.

Removal locations are concentrated around Glenview, Mt. Hannah Lodge, the St. Gregory of Sinai Monastery area, Loch Lomond, Adams, and Forest Lake, with additional locations near Seigler Springs and Ettawa Springs. Multiple tree locations may overlap at this regional map scale.

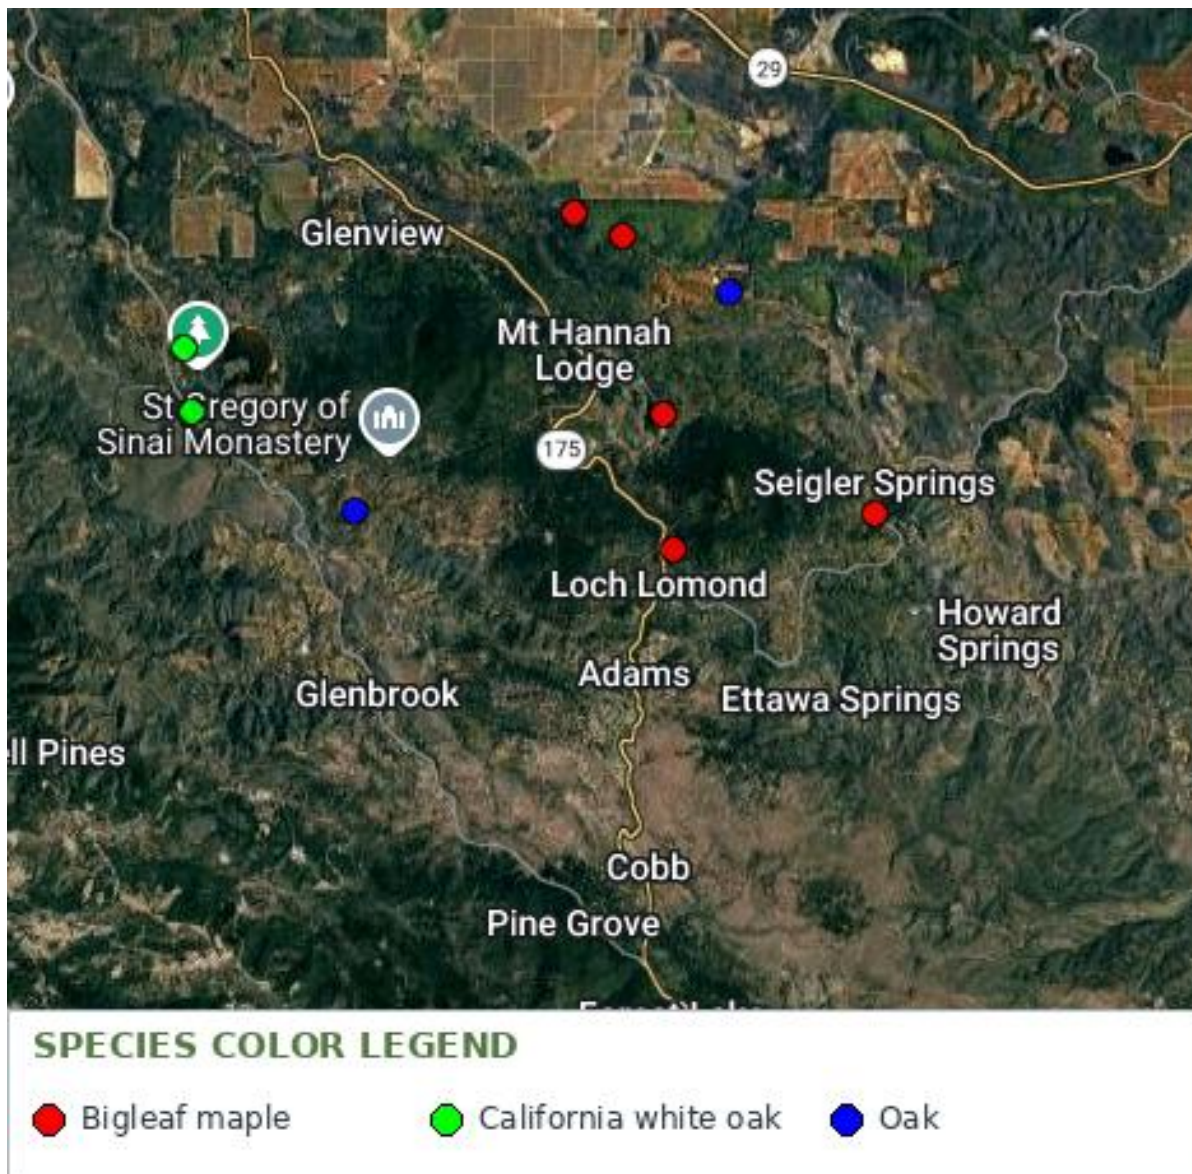
## Trees Recommended for Trimming

This map shows the locations of all nine trees recommended for trimming or pruning within the assessed County right-of-way. Each plotted point corresponds to a tree in the comprehensive TreePlotter inventory. Trees recommended for trimming were marked in the field with a purple dot at the base of the tree.

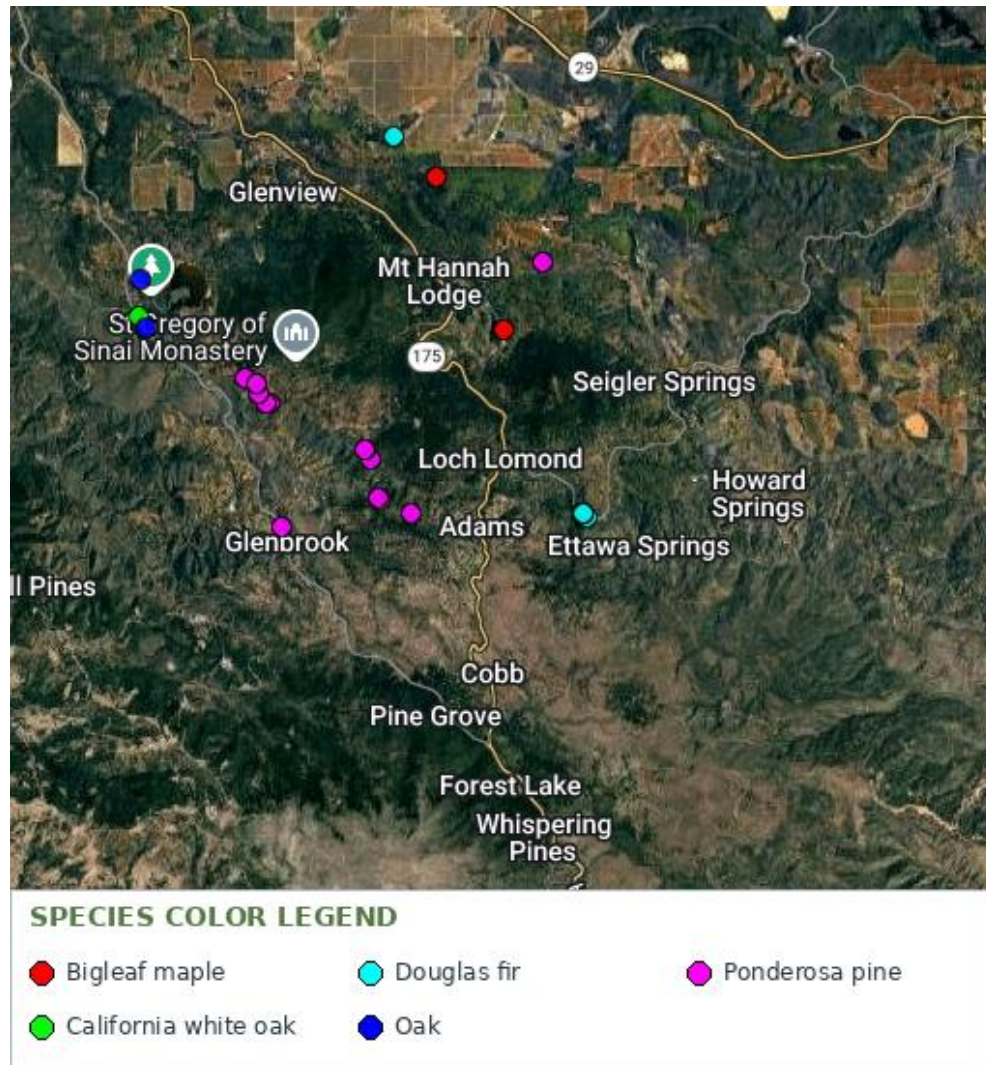
## Low Priority Trees

This map shows the locations of the 24 inventoried trees assessed as Low work priority. These trees remain part of the recommended scope of work but were determined to have a lower relative urgency than trees assigned Medium or High priority at the time of assessment.

Low-priority locations are distributed primarily around Glenview, Mt. Hannah Lodge, the St. Gregory of Sinai Monastery area, Glenbrook, Loch Lomond, Adams, and Ettawa Springs. Work may be grouped geographically with nearby higher-priority trees when practical, while maintaining the priority order established in the inventory.

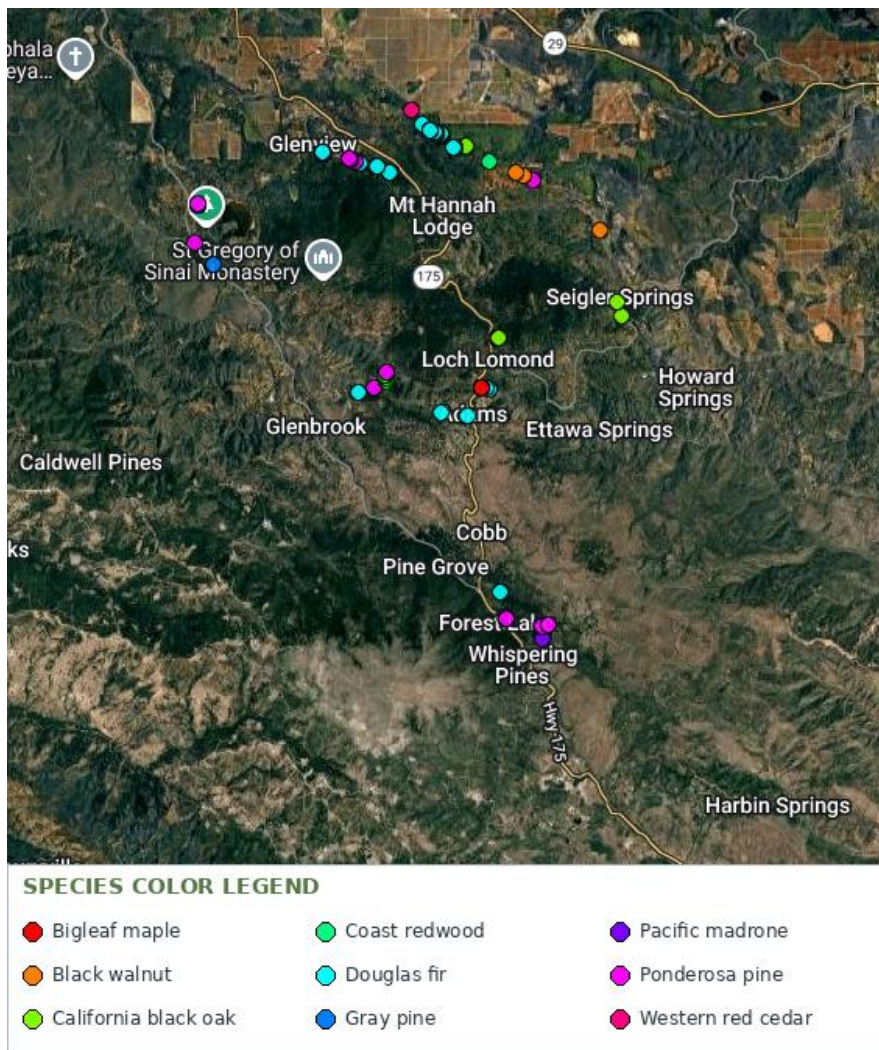
## Medium Priority Trees

This map shows the locations of the 86 inventoried trees assessed as Medium work priority. These trees require the recommended removal or trimming work but were determined to have a lower relative urgency than High-priority trees at the time of assessment.

Medium-priority trees occur throughout the assessed area, with visible concentrations around Glenview, Mt. Hannah Lodge, the St. Gregory of Sinai Monastery area, Loch Lomond, Adams, Seigler Springs, and Forest Lake. These trees should generally be scheduled after High-priority work, although geographic grouping with nearby High-priority trees may improve safe and efficient project delivery.

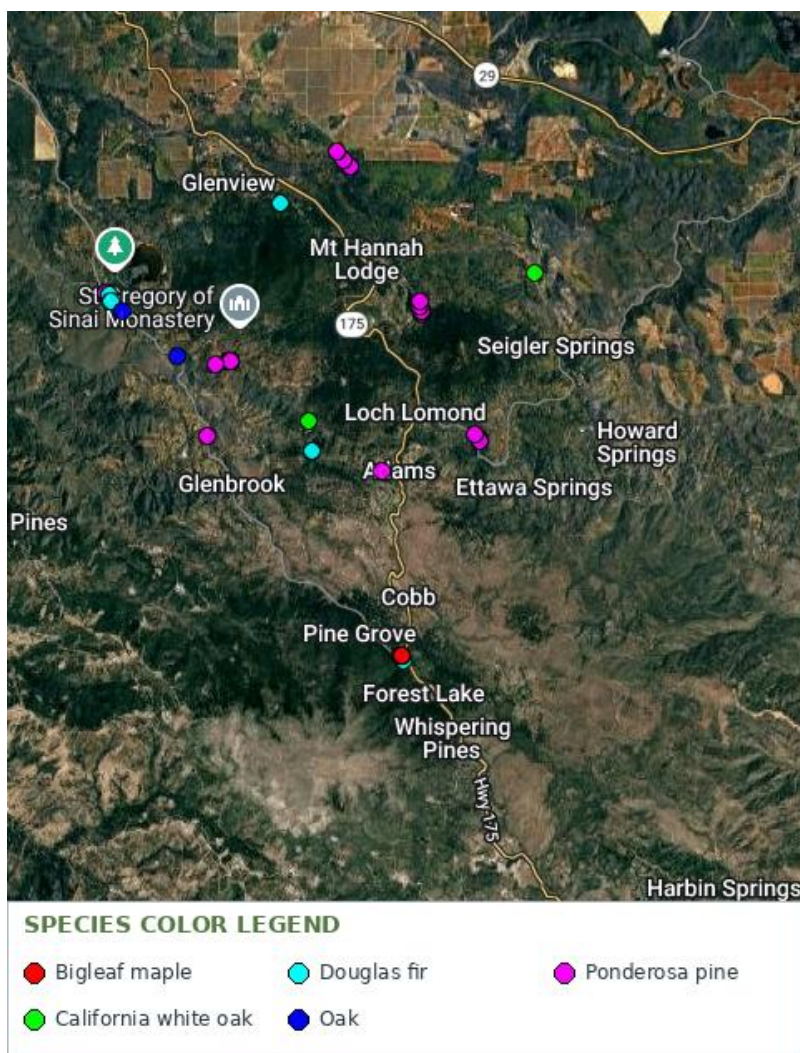
## High Priority Trees

This map shows the locations of the 40 inventoried trees assessed as High work priority. These trees represent the most urgent work identified during the field assessment and should receive the earliest attention based on their observed condition, likelihood of failure, and potential impact on the roadway.

High-priority trees are distributed around Glenview, Mt. Hannah Lodge, the St. Gregory of Sinai Monastery area, Glenbrook, Loch Lomond, Adams, Seigler Springs, and Forest Lake. Removal and trimming operations should begin with these locations, subject to safe access, traffic control, and current field conditions at the time the work is performed.
